FUNCTIONAL COMPLEXITY FAILURES AND AUTOMATION SURPRISES: THE MYSTERIOUS CASE OF CONTROLLED FLIGHT INTO STALL (CFIS)

Lance Sherry,
Center for Air Transportation Systems Research at George Mason University
Fairfax, Virginia
Robert Mauro
Decision Research & University of Oregon
Eugene, Oregon

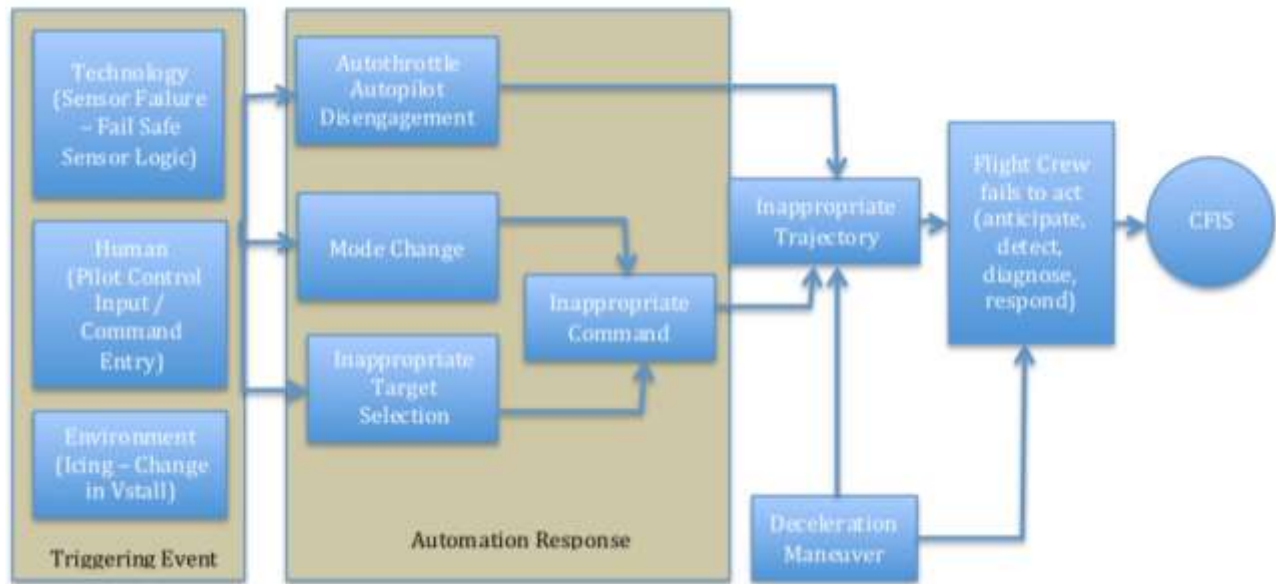
Nineteen accidents were reviewed. A list and summary of the accidents and their characteristics is included in Sherry et al (2014). All 19 accidents and incidents can be described by the sequence of events presented in Figure 1: A *triggering event* (e.g. sensor failure) has an *effect on the automation* (e.g. mode change). This leads to an *inappropriate command* for pitch or thrust. The inappropriate command occurs while the aircraft is experiencing a relative *deceleration* to the minimum safe operating speed. The relative deceleration is the result of either the aircraft decelerating to a fixed minimum safe operating speed or a change in the minimum safe operating speed (e.g. due to ice contamination on the wing). Finally, the flight crew *fails to intervene* to arrest the deceleration through the minimum safe operating speed and into controlled flight into a stall (CFIS).

Figure 1. Sequence of Events Leading to Controlled Flight Into Stall (CFIS)
